PROJECT CASE STUDY • RAIL INFRASTRUCTURE

# GRP access shaped to a demanding embankment

Glendouglas • QTS Group project

Embankment stairs and walkway

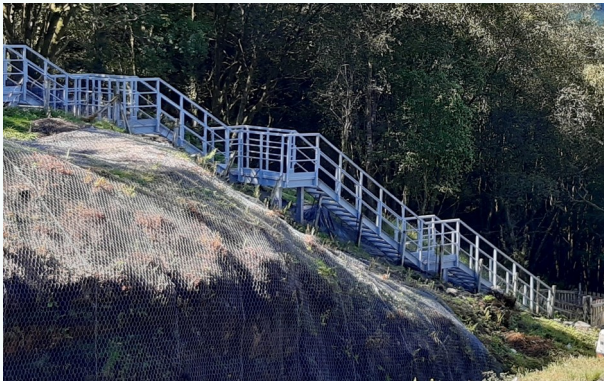
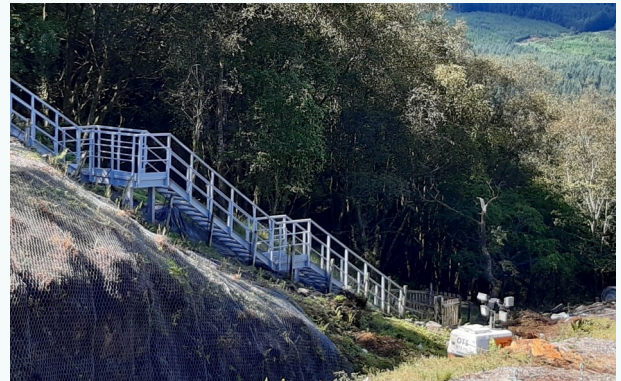
The original timber access was split by a gravel path and had become dangerously slippery. The replacement GRP route used stairs, mesh landings, handrails, safety gates and a connecting walkway shaped around the changing terrain.

The first section followed a relatively gentle slope but required a 34 m route to descend 9.6 m, with a 45-degree direction change at the bottom. A steeper lower section required four further changes of direction, while a grating walkway replaced the gravel link between the two stair sections.

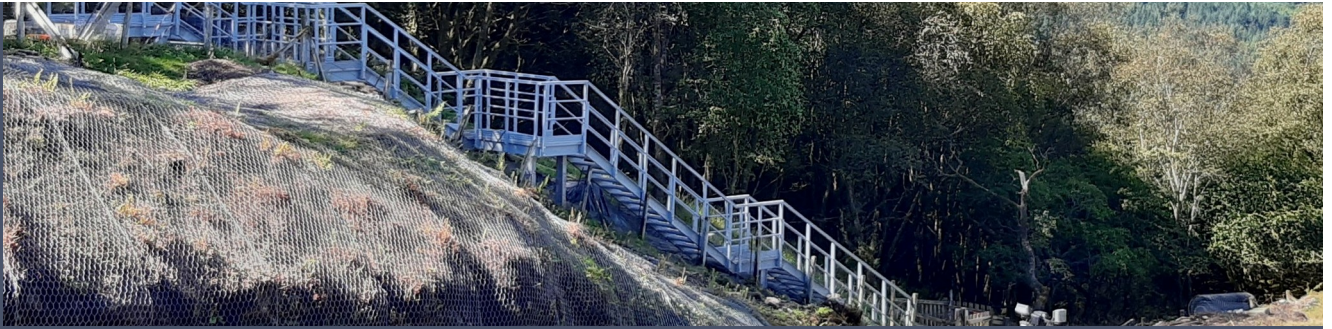
The completed arrangement replaced slippery timber stairs and a gravel link with a coordinated GRP access route.

The upper stair flight follows the gentler slope before changing direction to meet the ground-level route. A grating walkway then connects to the steeper lower section, where intermediate landings and further direction changes manage the descent toward the trackside access point.
